Re: CC Docket No. 94-102
Notice of Ex Parte Communication

The meeting participants discussed test results of SnapTrack's technology for locating wireless handsets. At the meeting, SnapTrack distributed the enclosed documents.

SnapTrack Field Tests
February 23-26, 1998
Results summary chart

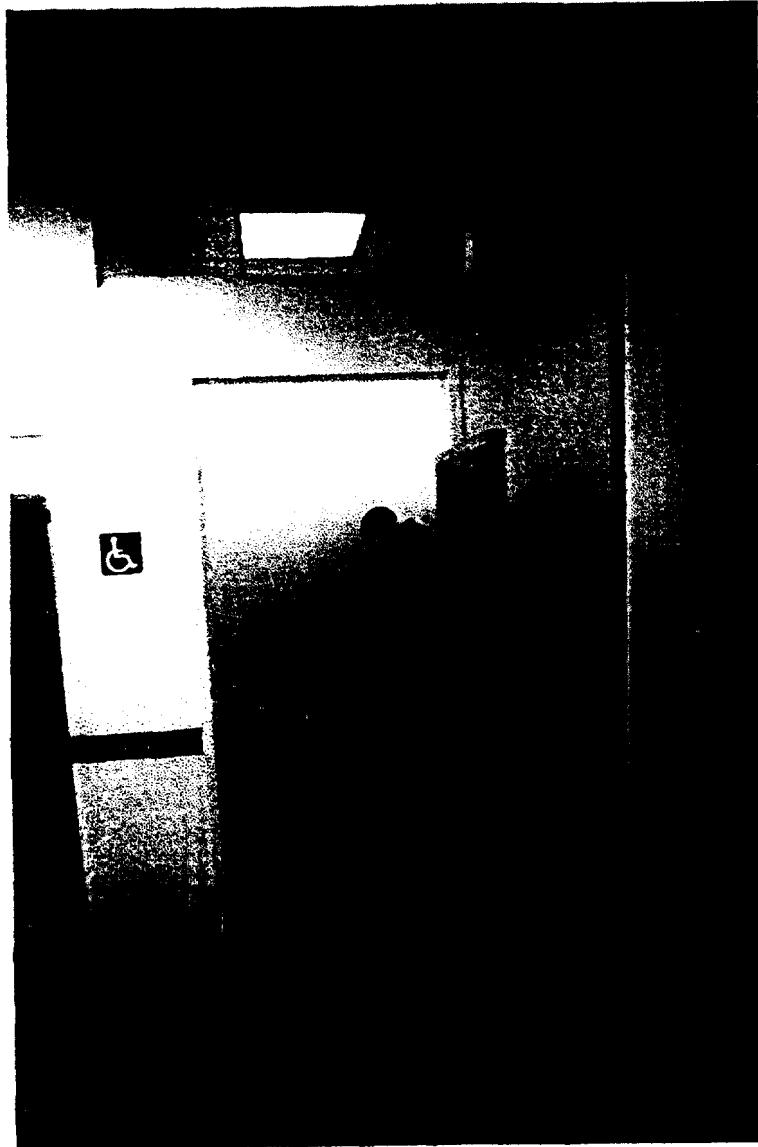
Indoor, 2-story office building (brick)

Photograph: Test Location #2, 1st floor interior room in center of building

Location: 2045 Broadway, Boulder, Colorado

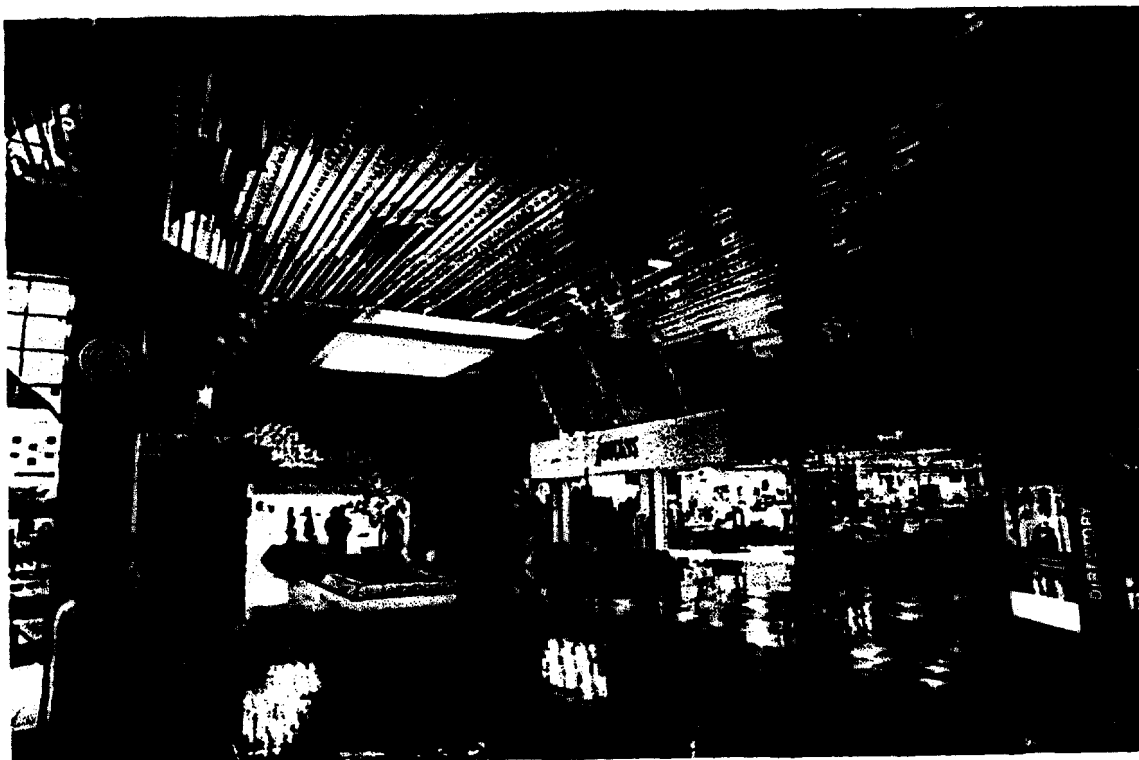
Indoor, shopping mall

Photograph: interior test location (inside walkway)
Location: Westminster Mall, Denver, Colorado
